Erosion of the riverbank at Caley Green

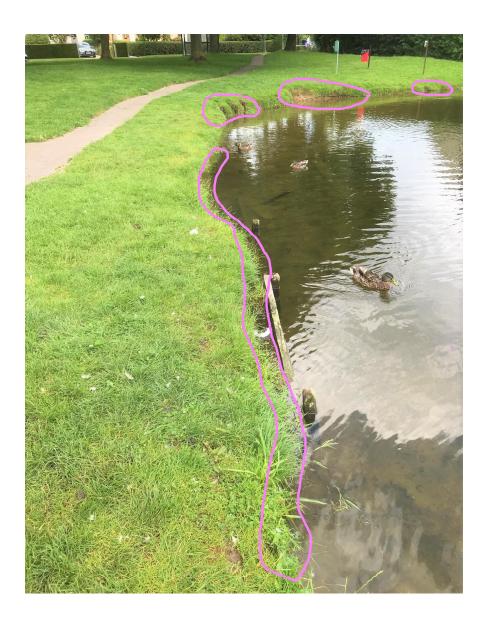
During recent months the intensity of boating, swimming etc using the river at the Caley Green 'hotspot' appears to be increasing the erosion of the riverbank, particularly in the vicinity of the disintegrating existing wooden revetment.

Photo 1 – Stretch of river bank at Caley Green (looking NorthEast) showing areas of eroded bank (and extent of existing but decaying wooden revetment)

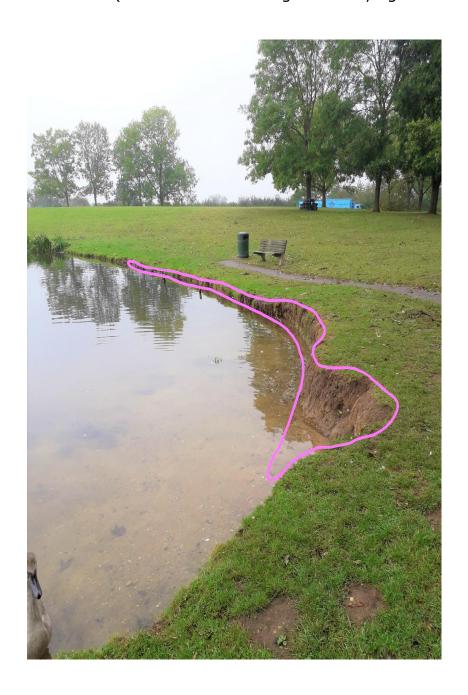
Photo 2 - Stretch of river bank at Caley Green (looking South-West) showing areas of eroded bank (and extent of existing but decaying wooden revetment)

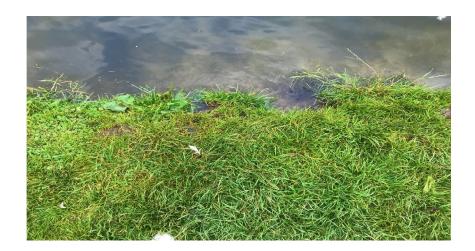
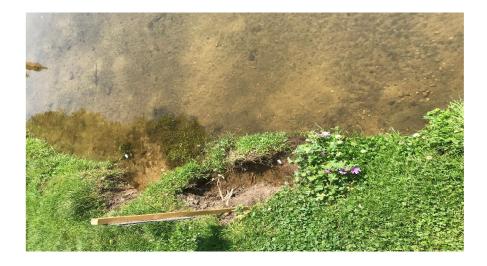
It's likely that some of the erosion is due to:

- Watercraft users nosing their craft into the bank to stop and get out of the water; some solid craft have quite sharp, hard, bows
- Watercraft users using their oars to push off from the riverbank
- Jumping into the water onto their watercraft, exerting extra force on the bank edge
- General river users, e.g. swimmers, paddlers, boaters climbing in and out of the water etc

Photo 2,3 – Close-up views of part of the river bank at Caley Green showing recently detached sections of the bank about the fall into the river

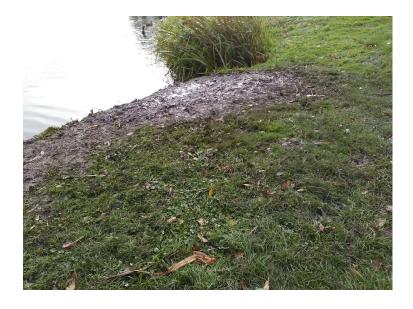
In 2016 the reed beds were unofficially cut down and the roots dug out (see photos below taken at the time).

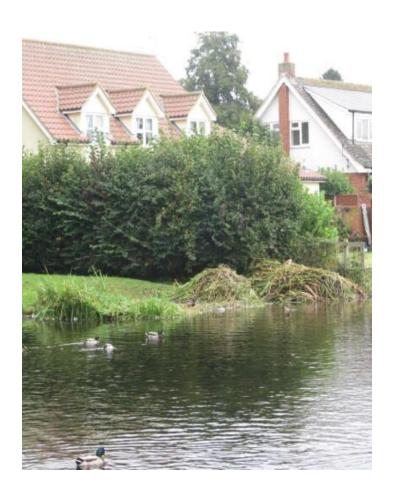
Photo 4 – Reed bed area of riverbank after removal of reeds and roots
