Erosion of the riverbank at Caley Green

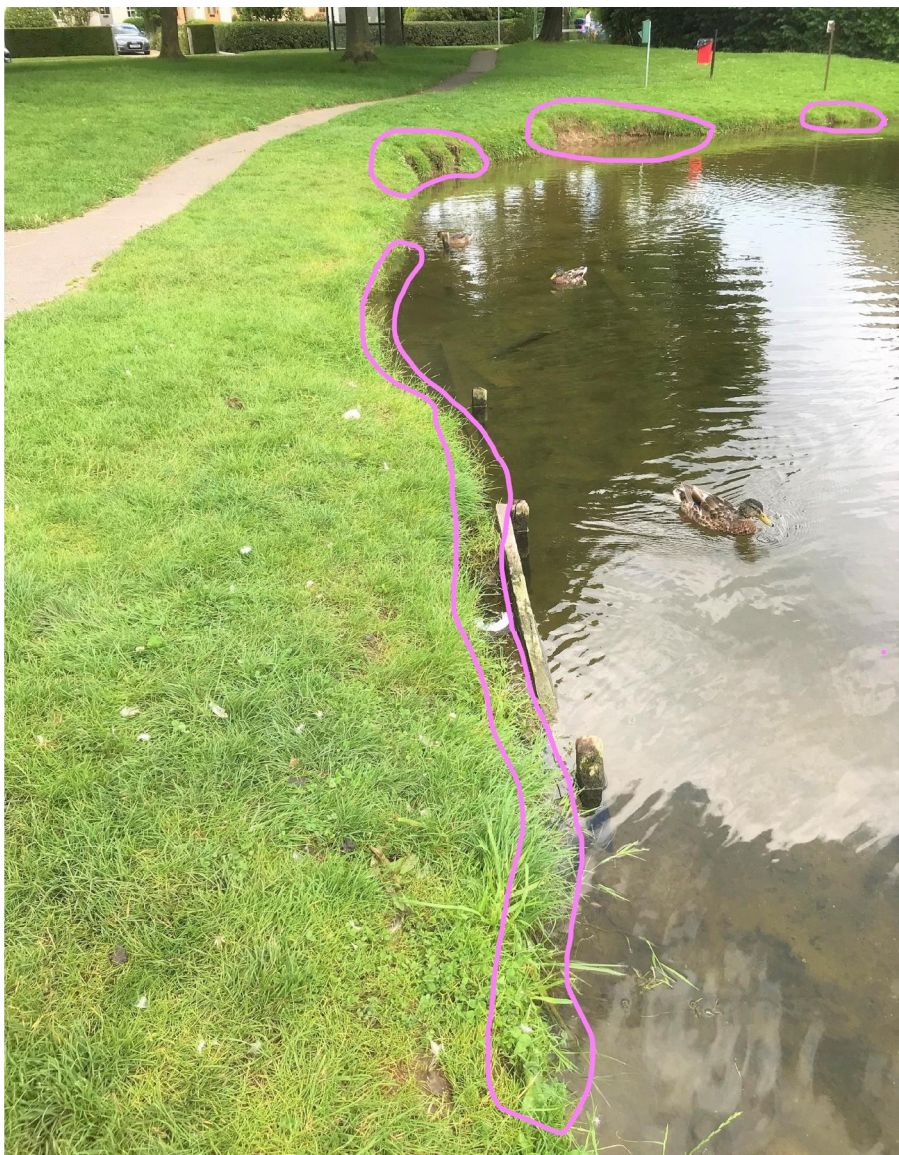
During recent months the intensity of boating, swimming etc using the river at the Caley Green 'hotspot' appears to be increasing the erosion of the riverbank, particularly in the vicinity of the disintegrating existing wooden revetment.

Photo 1 – Stretch of river bank at Caley Green (looking NorthEast) showing areas of eroded bank (and extent of existing but decaying wooden revetment)

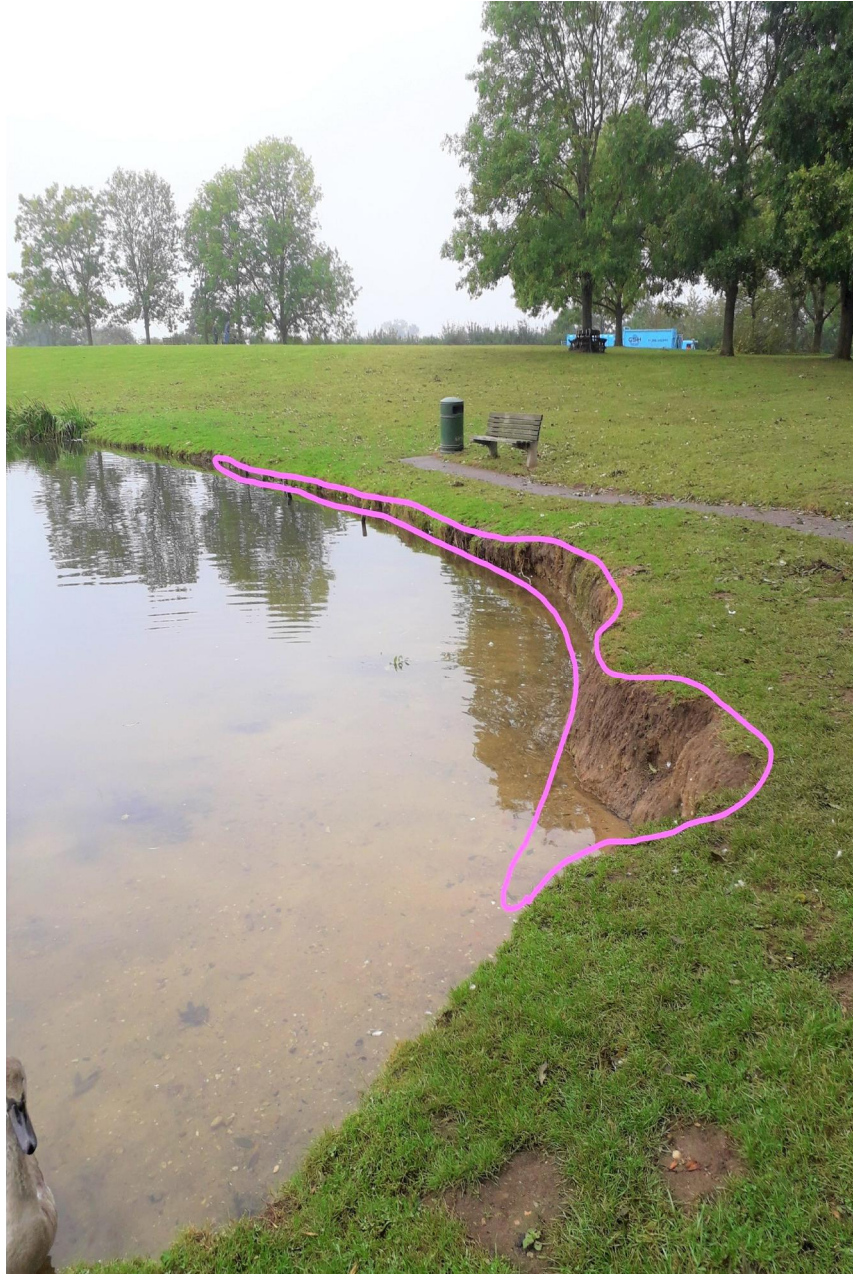
Photo 2 - Stretch of river bank at Caley Green (looking South-West) showing areas of eroded bank (and extent of existing but decaying wooden revetment)

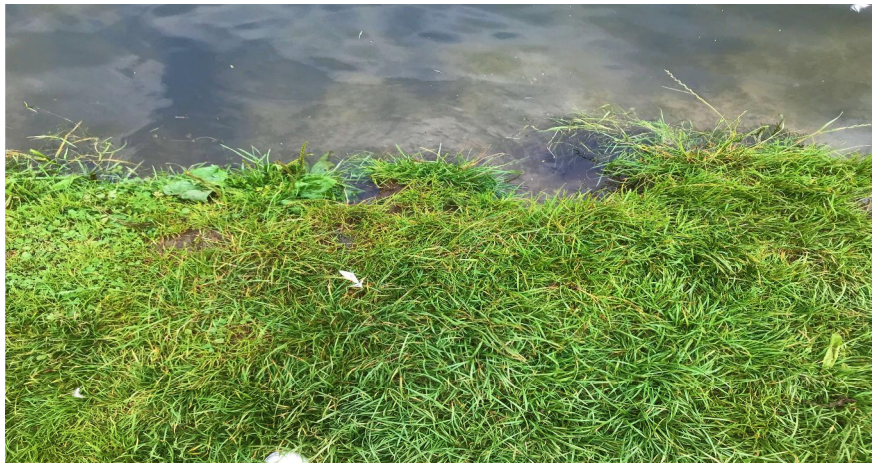
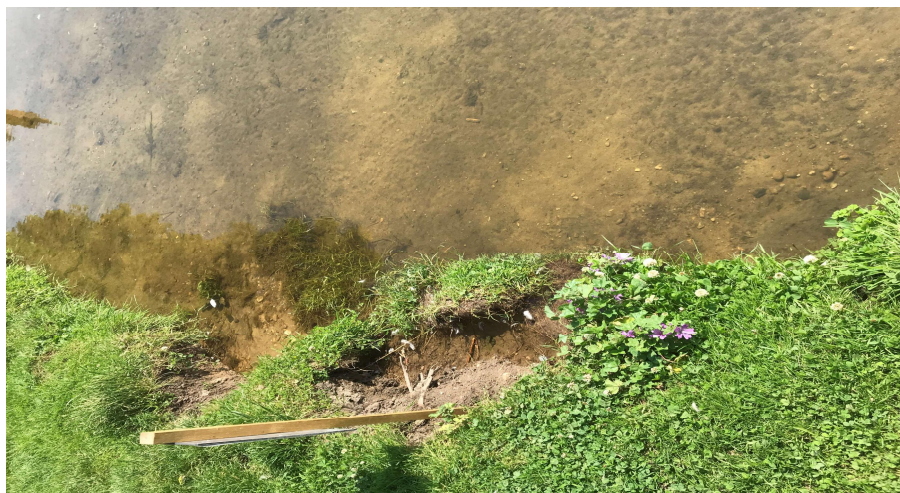
It's likely that some of the erosion is due to:

- Watercraft users nosing their craft into the bank to stop and get out of the water; some solid craft have quite sharp, hard, bows
- Watercraft users using their oars to push off from the riverbank
- Jumping into the water onto their watercraft, exerting extra force on the bank edge
- General river users, e.g. swimmers, paddlers, boaters climbing in and out of the water etc

Photo 2,3 – Close-up views of part of the river bank at Caley Green showing recently detached sections of the bank about to fall into the river

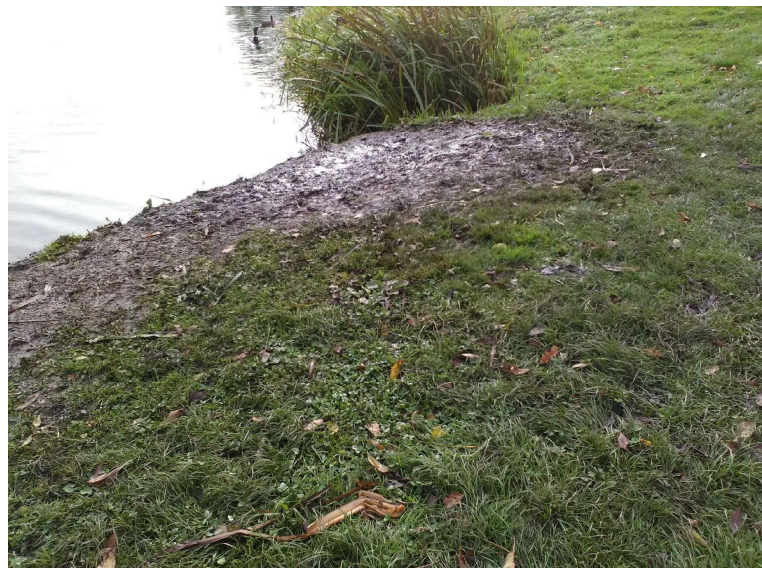
In 2016 the reed beds were unofficially cut down and the roots dug out (see photos below taken at the time).

Photo 4 – Reed bed area of riverbank after removal of reeds and roots

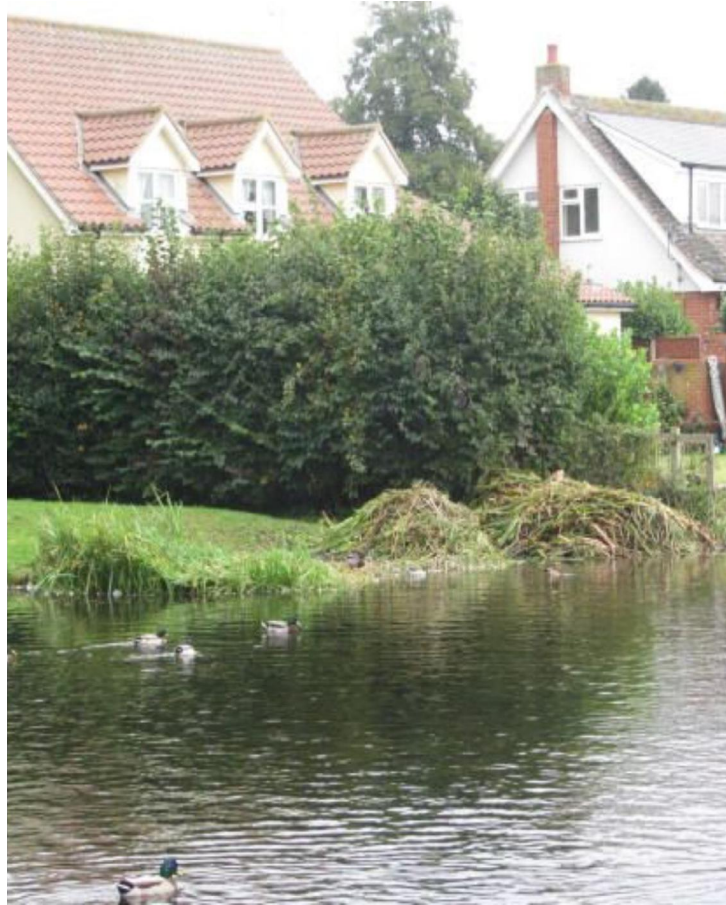
Photo 5 – Remains of reed removal, cleared away by the Parish Council
