Erosion of the riverbank at Caley Green

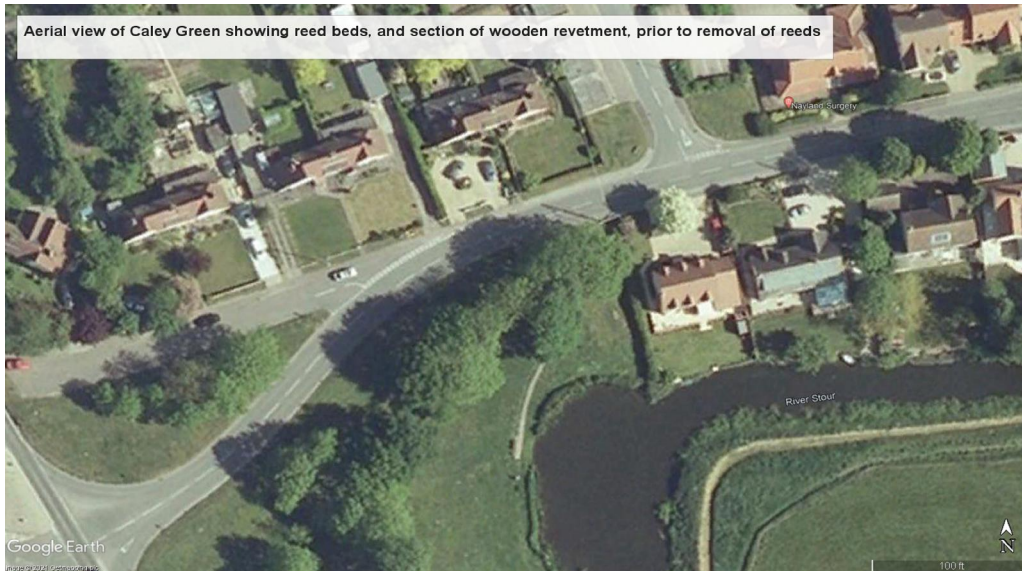
A Google Earth image (below) shows an aerial view of Caley Green with reed beds along the riverbank section of Caley Green opposite Bear Street, and showing the extent of the wooden revetment.
